**Overview:**

This report is being issued to create understanding of the extent of the problem and unanswered requests for information and action.

**FLAG report, comment and request for action:**

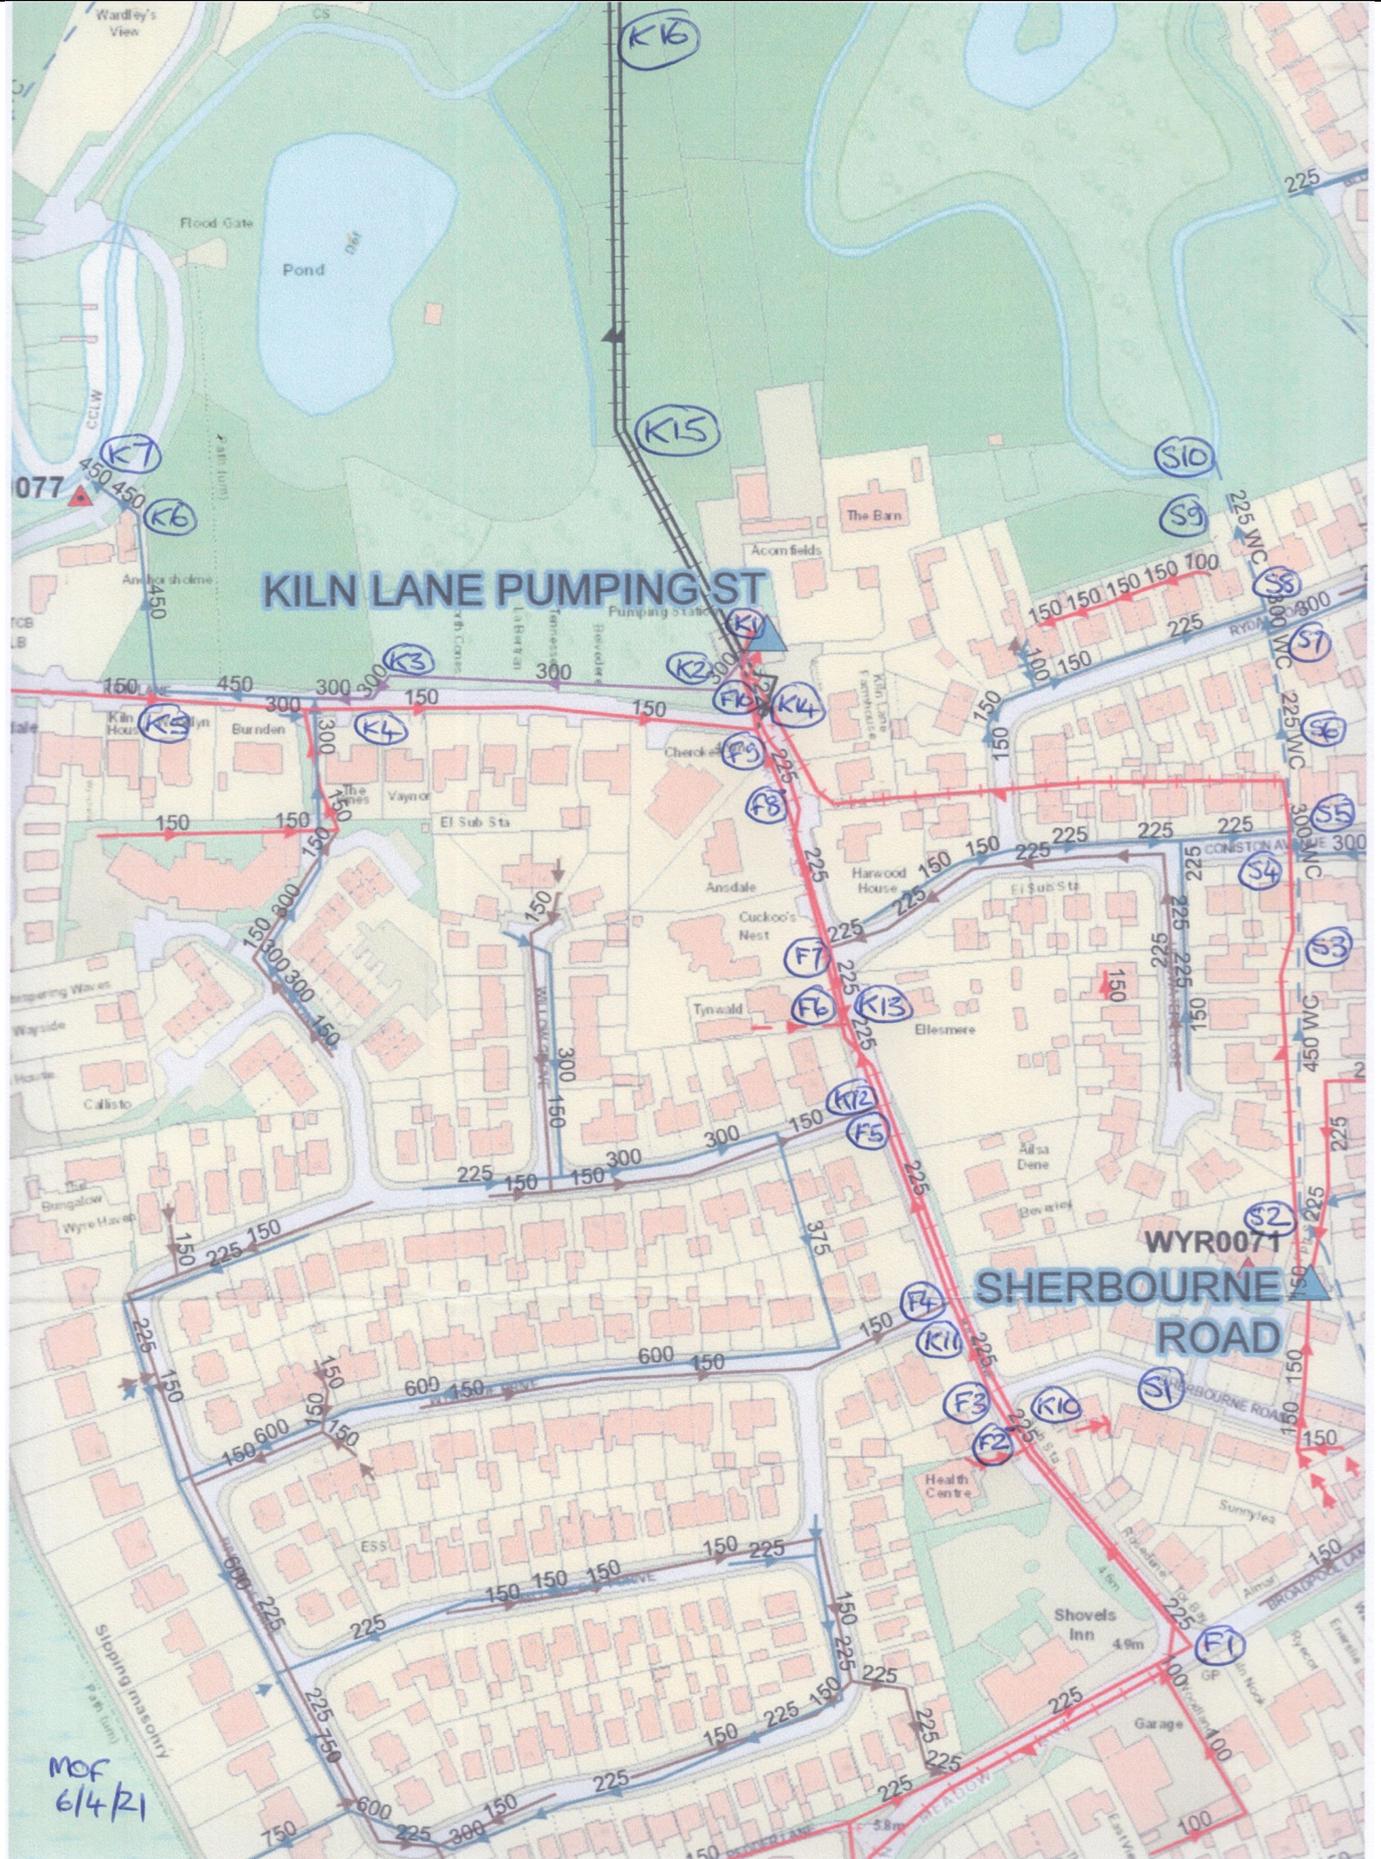
The general plan included here shows the areas relative to Kiln Lane and Sherbourne flooding.

The manholes and gullies in Kiln Lane, during flooding can all be observed surcharging up and flooding the road. At Sherborne Rd the flooding regularly enters houses, along Kiln Lane the roads are flooded to 300 or 400 mm (notwithstanding a central high area). Because the gullies and the manholes surcharge it was thought that Kiln Lane was a combined surface and foul system; it would now appear that it is separate, our requested for information showing this is outstanding.

This surface water drains from Sherbourne Road to the piped water course which outfalls into Kiln Lane Watercourse. The system is shown on the plans (ref S1 to S9) as 450WC, 300WC, 225WC, 300WC, 225WC. Also connected into this system are the surface water drains from gullies in; Rydal Rd, Coniston Ave, Birchwood Drive, Woodhall Gardens, Broadpool Lane, Ryecroft Ave., Sandy Lane, Pauls Lane, Stoney Lane, Market Street, Arthurs Lane, Broadlands Ave, Crookland Gardens and Aldwath Close; which lends a particular importance for this line to be operable. These lines also include further sections of riparian ownership piped water courses. There appears, from the plans supplied, to be a reduction of pipe diameters in the direction of flow when an increase would normally be the correct engineering solution.

**Ref S4-S5**-300mm diameter WC pipe under Footpath South -Coniston Ave-Footpath-North responsibility UU. The WC pipe show reduces in size from 450mm diameter to 300mm diameter, reducing capacity by 56%. There are pipes from road gullies feeding in from the east on the south side and from the west on the northside. These are 90 degree changes of direction. Can UU consider the installation of a manholes for inspection and maintenance. The North Footpath outside 17 Coniston shows evidence of subsidence.

**Ref S5-S6**-225mm diameter WC-Pipe under garden of Riparian owner 17 Coniston north. The WC pipe reduces further in size from 300mm diameter to 225mm diameter, this is a reduction in capacity, compared to the 450mm diameter pipe of 75% !!
